# DEVELOPMENT REPORT FOR HIGH-RELIABILITY, LOW-COST INTEGRATED CIRCUITS 3 NOVEMBER 1977 TO 3 SEPTEMBER 1978 Prepared By RCA Solid State Divison Route 202, Somerville, N.J. 08876

> Contract No. N00039-76-C-0240 Project No. 62762N Subproject No. XF54586 Task No. 002

Thermal-shock testing of HRLC (high-reliability, low-cost) product has defined a beam-tape design problem which has necessitated the redesign of the beam tapes on all types. Life-test matrices have been run on CD4012 and CA741 to gain a preliminary insight into the failure modes to be expected in Phase III.

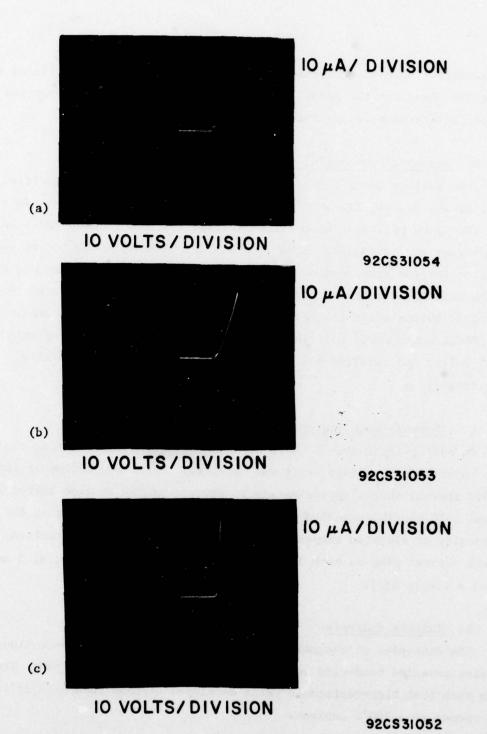
The decapping of thermal-shocked devices that failed hot-continuity testing revealed bond-wire heel cracks at the device bonding pad. The cracks were such that high-resistance paths developed through them at a 25°C ambient, but opened at a 100°C ambient.

Fig. IV-1 shows curve-tracer photos of input-continuity tests for a CA741 after 128 hours of 250°C storage life. The "on" portion of the slope of the failed-unit trace indicates the increase in input resistance resulting from

Fig. IV-1 - Curve tracer examination of input resistance in CA741 at pin 4. (a) Control measurement. Good DIC, slope  $\simeq$  60 k $\Omega$ . (b) HRLC device on 250°C 128-hour storage-life test. Slope  $\simeq$  330 k $\Omega$ . Unit failed input-offset voltage test. ( V  $_{10}$  > 17 mV) (c) Same HRLC device as in (b) on 250°C 128-hour storage-life test after curve-tracer stress to close resistive gap. Slope  $\simeq$  60 k $\Omega$ . Unit now passes input-offset voltage test. (V  $_{10}$  < 1 mV)

the fracture at the heel of the bond. Pin 4 is the inverting input to the unit.

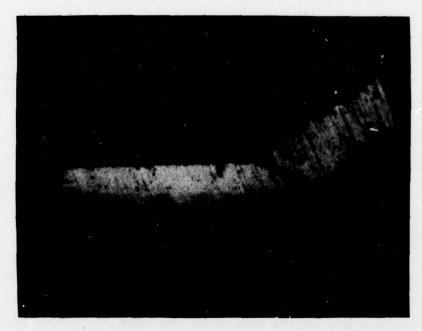
Fig. IV-2 is a photograph of a cross sectioned device showing the typical location and character of heel breaks.

The cross-sectional view in Fig. IV-2 was made to show the beam-tape finger, the inner-lead bond, and the bumped chip in the area where electrical testing indicated a high-resistance connection so that the failure mode for devices that failed thermal-shock cycling could be analyzed.

The fracture in the beam tape is shown to occur at the heel of the inner-lead bond in the 0.003-inch width, Fig. IV-3, which extends 15 to 20 mils from the end of the finger. A study of the tape design revealed that, in this localized area, the total stress on the beam-tape finger is concentrated and that, under fatigue stress conditions, the failures could be anticipated. Such failures begin as small cracks on the surface of the part and, as the cracks propagate, they progressively reduce the ability of the weakened section to withstand the strain. This condition is particularly important at the heel of the bond where the cross section of the lead is reduced as a result of the thermocompression bonding process.

Fig. IV-2 - Typical heel break (high resistance - 200 k ) of pin 11 on CA741 stressed at 250°C standard life. Device failed after 128 hours and 7 down periods. (V<sub>IO</sub> = 17 mV)

A redesign of the beam-tape was made which minimized the stress concentration in the 0.003-inch-width sections of the tape. A 90° bend in the plan view of the finger, Fig. IV-5, prevents tensile strain from being transferred from one section of the beam to another.

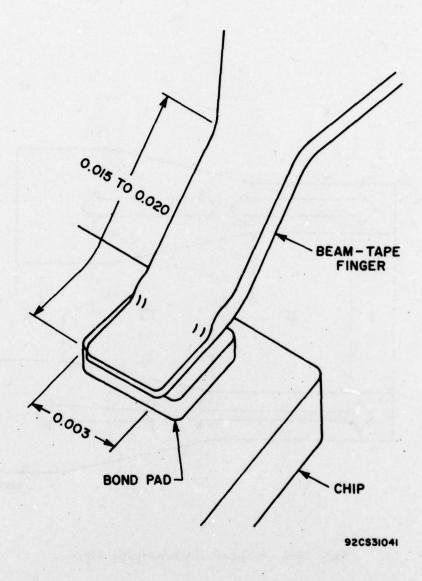
Fig. IV-3 - Schematic drawing of the portions of the beam-tape finger, inner-lead bond, and bumped chip involved in heel breaks.

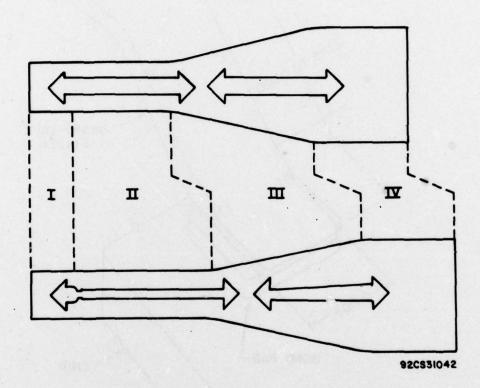
Fig. IV-4 illustrates the magnitude of the strain that is present in a straight, short finger under mechanical loading. Sections I and IV represent the inner- and outer-lead bond areas, respectively. The strain in sections II and III under load is shown to be concentrated in section II because of the higher unit stress. The point where section I ends and section II begins is the heel of the inner-lead bond where, again, virtually all of the lead breaks occur.

Fig. IV-4 - Strain in beam-tape finger.

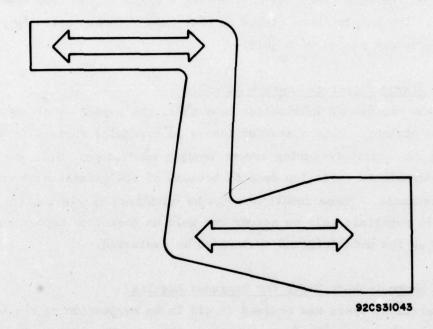
Fig. IV-5 - Strain in redesigned beam-tape finger.

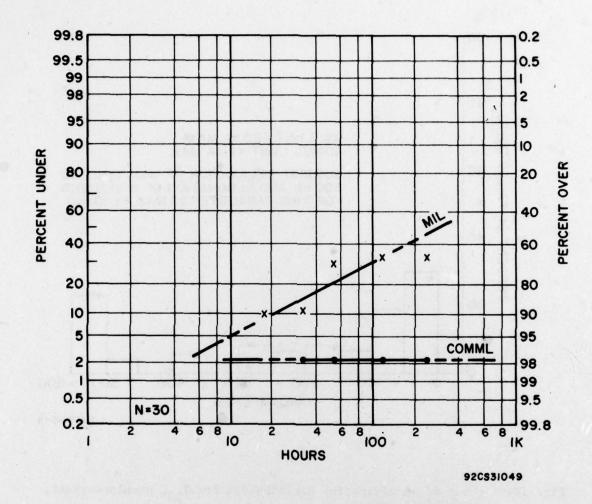
Fig. IV-6 is a log-normal failure plot for CD4012 wire-bonded units packaged in silicone and stressed at  $250^{\circ}$ C in bias-life circuits. The failures for MIL limits at 128 hours were 33 percent of the total sample. Most of the units failed for leakage currents. All out of specification units and many not out of specification exceeded the 10 nanoampere MII, delta criteria for  $I_{SS}$ .

Fig. IV-6 - Log-normal failure plot for CD4012 wire-bonded units packaged in silicone and stressed at 250°C in bias-life circuits.

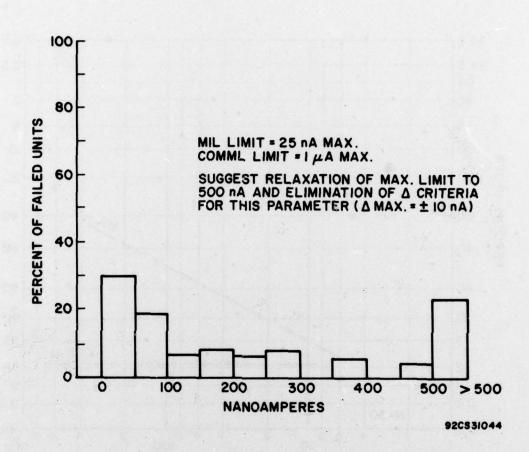
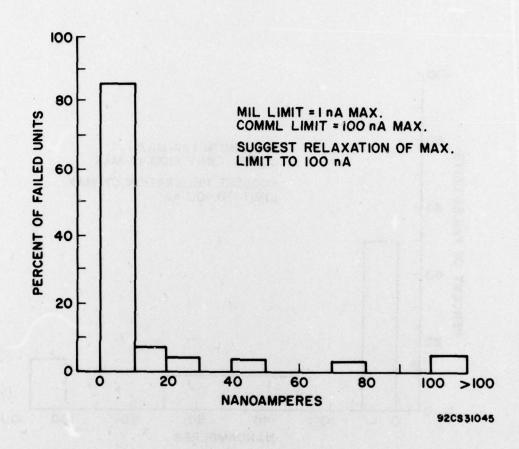
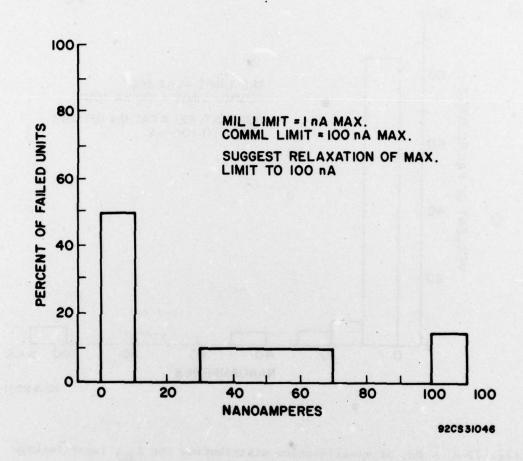
Figs. IV-7, IV-8 and IV-9 are histograms of the prevalent leakage problems, and show distributions based on total number of out of specification units. A large percentage of limit failures occur in the region just above the MIL limit.

Fig. IV-7 - Out of specification distribution for I<sub>SS</sub>, supply current, in CD4012 devices.

Fig. IV-8 - Out of specification distribution for I<sub>IL</sub>, input leakage current, low level, in CD4012 devices.

Fig. IV-9 - Out of specification distribution for I<sub>IH</sub>, input leakage current, high level, in CD4012 devices.

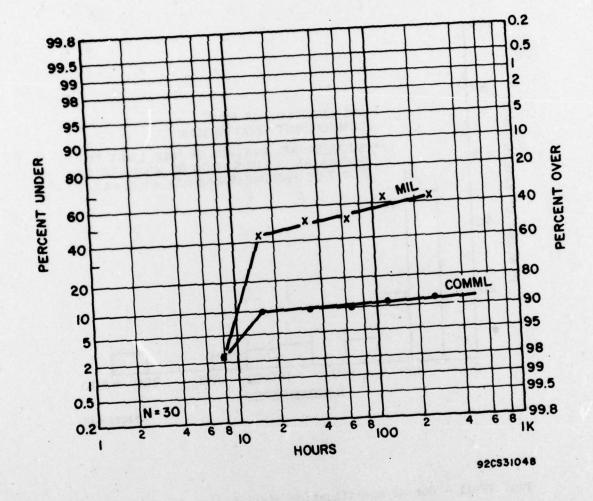
Fig. IV-10 shows a failure plot for the CA741 wire-bonded silicone-packaged units. Most of these failed units were out of specification for input bias current; Fig. IV-II shows the distribution of these failures. All failures and most of the units that did not fail exceeded the MIL delta requirement of 12 nA for end points.

Fig. IV-10 - Failure plot for the CA741 wire-bonded silicone-packaged units.

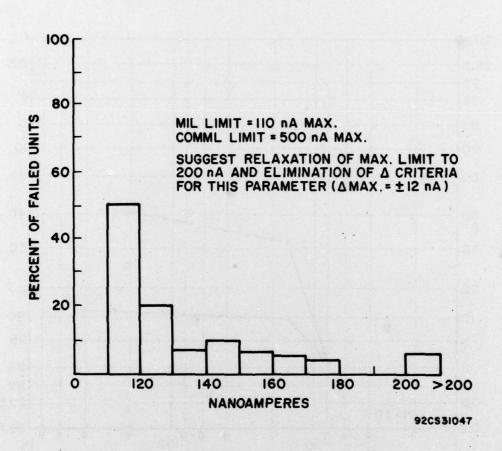
Fig. IV-11 - Out of specification distribution for I<sub>IB</sub>, input bias current, in CA741 devices.
